Dissimilar Weld Failure: A Forensic Analysis to Determine Primary Failure Mechanisms

Solar receivers are an integral part of a concentrated solar power plant and commonly utilise tubular structures to absorb solar energy and transfer the heat into a heat transfer fluid. These systems often contain dissimilar materials to minimise the cost of the system. These sections, joined through welds, are exposed to frequent cyclic temperatures daily or as weather conditions change throughout the day.. This presentation will focus on the failure of a receiver exposed to 780°C, where cracks were observed near the welded tubing segment of Haynes 230 (Ni alloy) and 253 MA (stainless steel) as shown in Figure 1. A range of analysis techniques have been brought together, , such as Micro Computed Tomography (micro-CT), Scanning Electron Microscopy (SEM) and X-Ray Spectroscopy to understand the root cause of the failure and provide approaches to avoid cracking in the future.

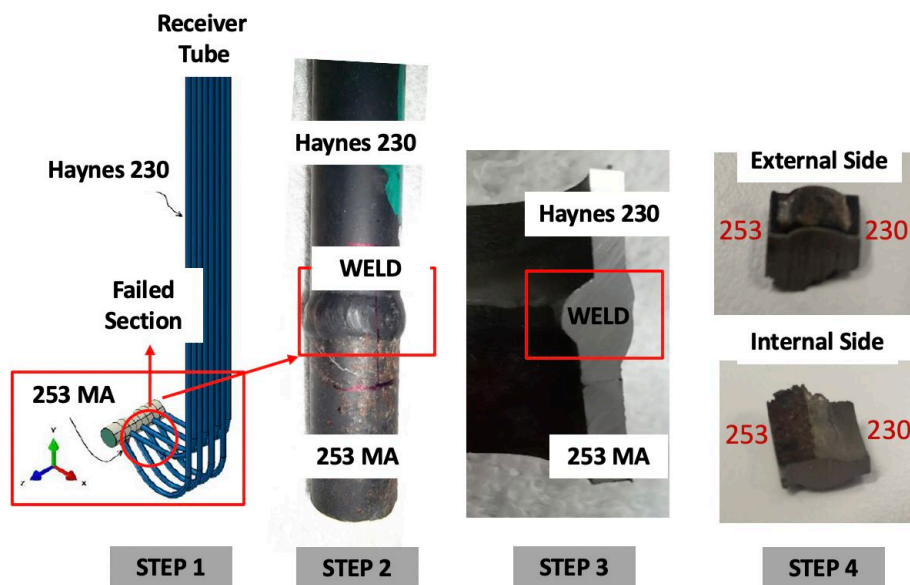
Figure 1. Crack observed on an adjacent weld (Haynes 230 - 253 MA) of a receiver tube. The section was down-sized for further investigation

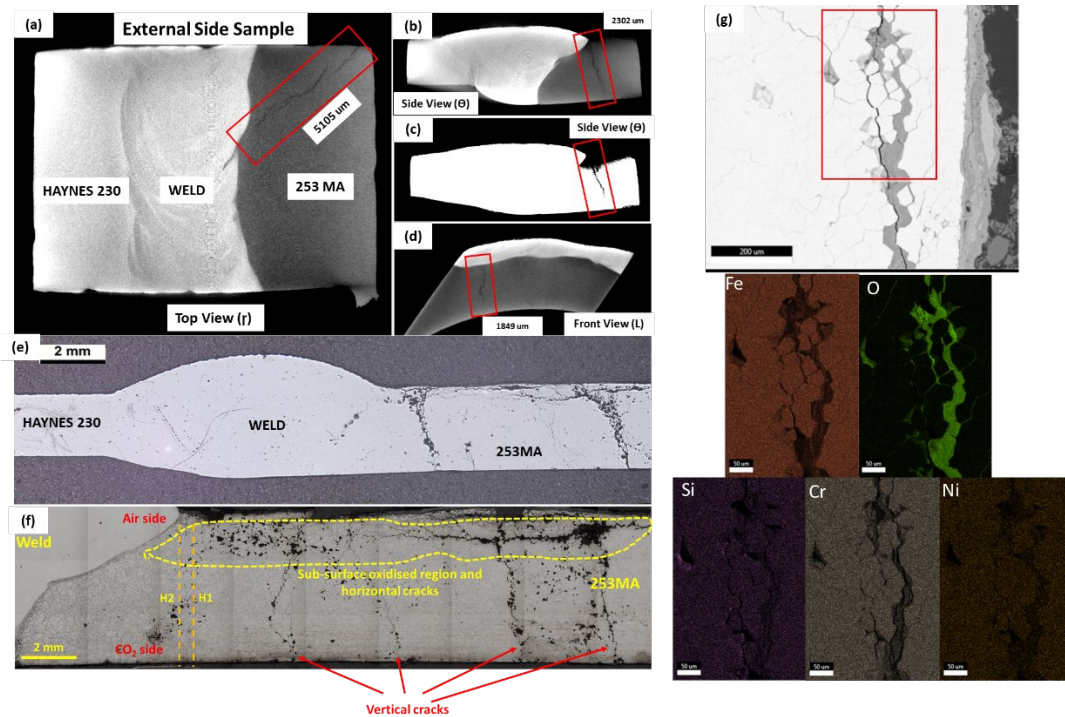
Analysis showed that the interface between the weld and Haynes 230 is almost defect free. Cracks were observed on both internal and external sides of 253 MA with multiple crack initiation points (Figure 2 (a-f)), regardless of the difference of air or CO₂. Surface oxidation and de-alloying occurred in the near surface region in addition to significant oxidation of grain boundaries which can be seen in Figure 2 (g). Importantly, the area adjacent to weld showed no carbide formation at the grain

boundaries on both air and CO₂ sides or any other significant chemical changes that could have been associated with the welding processes, suggesting that carburisation is not the case causing the alloy degradation. The cracks can be caused by the significant levels of stress that was produced when temperatures were elevated upto 780 °C. Upon such thermal stress, grain boundary oxidation in 253 MA away from the weld can be propagated and the multiple cracks can be ignited, that propagated along the grain boundaries of 253 MA consistent with brittle failure in the section. The analysis indicates that failure starts when the surface of 253 MA oxidises. The oxidation further develops to the sub-surface regions via the diffusion of oxygen through grain boundaries, in the presence of thermal or mechanical stresses, forms the horizontal cracks. Longitudinal forces then contribute to crack propagation in the vertical direction.

In summary, it is likely that the oxidation processed being prompted by thermally induced stresses caused the ignition of the cracks on the 253 MA side, and also provided the driving force for the crack propagation. It is probably that the failure related due to thermal cycling and therefore cyclic stresses following severe oxidation and metallurgical damage to the 253 MA in particular, resulting in the mechanical failure of the tube eventually.

Figure 2. Micro-CT cross-section images showing (a) top view, (b) side view, (c) side view (binarized image), with pixels representing metal segmented as solid (in white colour), (d) front view (grey-scale image) of a main crack distributed inside 253 MA bulk. Optical Microscopy of cross-section tube at crack locations (e) Haynes 230 weld and 253 MA and weld; (f) higher magnification of the weld and 253 MA. (g) Element mapping showing a region enriched with oxygen compounds along the main crack propagation.
