Survey of faults and issues with PV systems and components

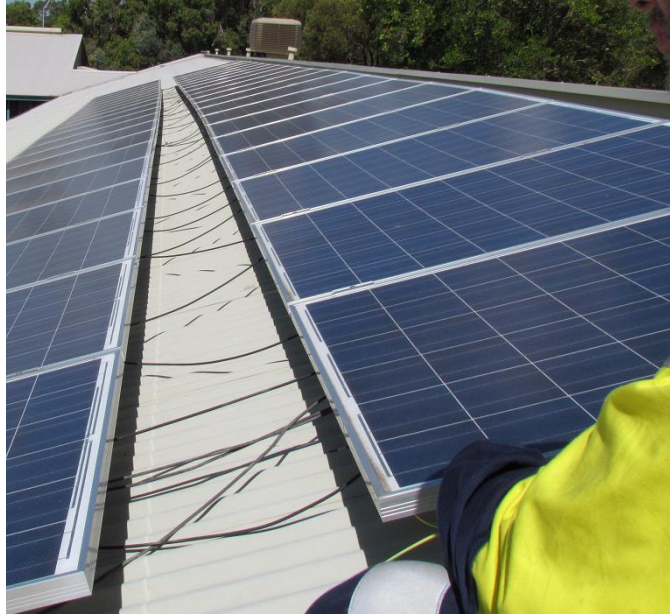
Figure 2: System with inadequate cable protection for PV wiring. This cable protection is needed as heat and especially UV radiation will affect the insulation of the cables. Over the expected lifetime of the PV system (25 years or more), these cables can deteriorate and increase the risk of short-circuits and fire, or will require expensive replacement work, thus affecting the financial return of the system.

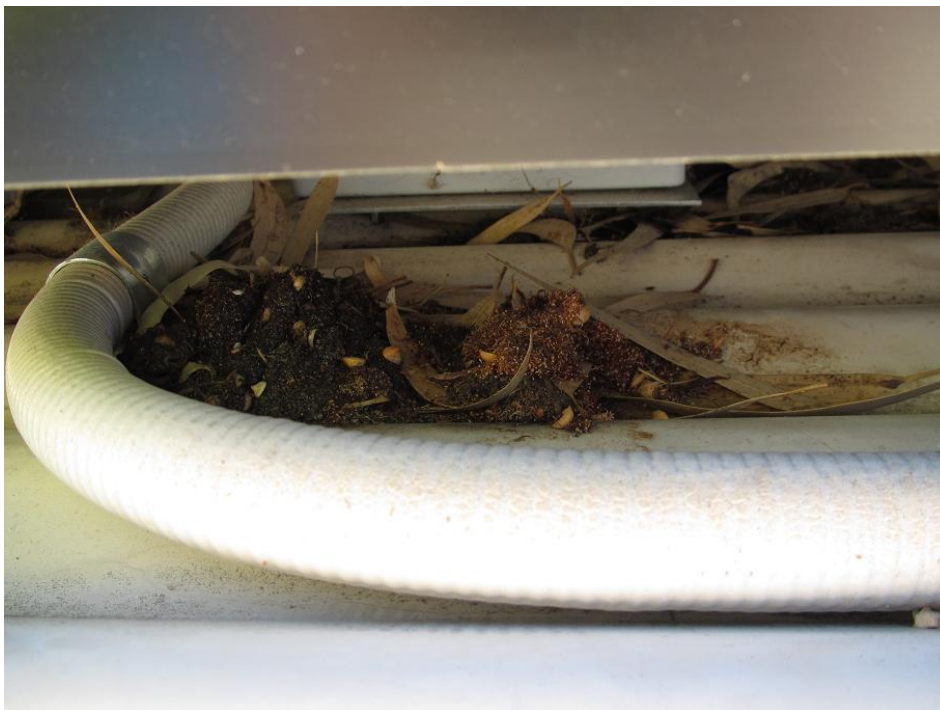
Figure 3: Example of accumulation of leaf litter under PV array panels due to the installation not facilitating self-cleaning. This is of concern because flammable material in close vicinity of a PV array installation presents a fire risk since high resistance faults (caused for example by component failures, bad joints or vermin activity) can lead to arcing.

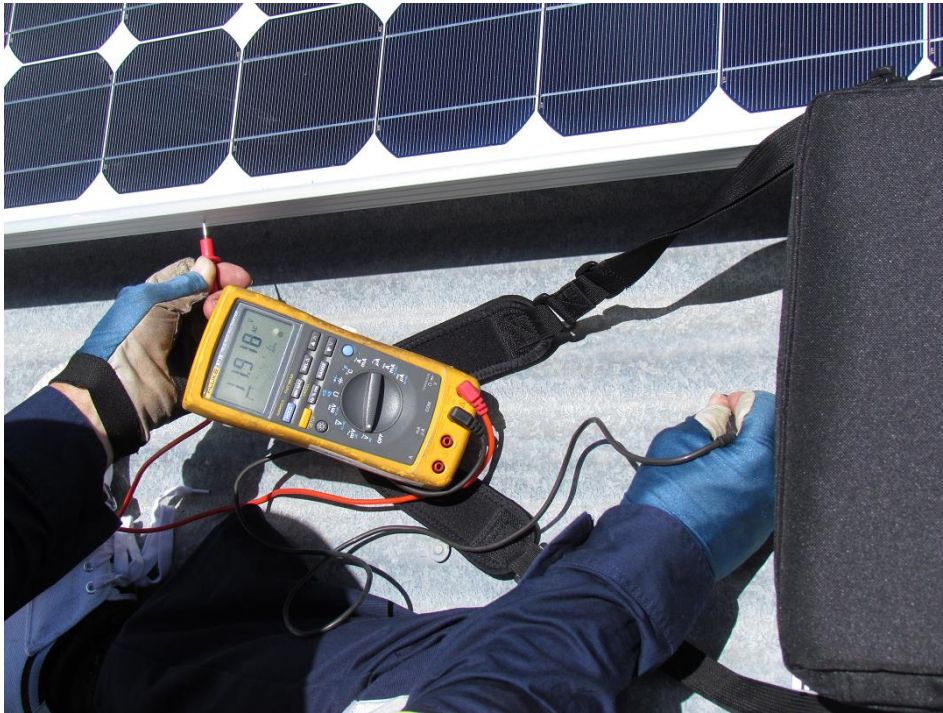
Figure 4: Unearthed PV module frame at potential relative to earth. Although 11.92V is not a hazardous potential, and unlikely to be detected without a Voltmeter, an unearthed PV array can be at a potential different from earth. This particular case was not hazardous when inspected. Under differing conditions and particularly in systems where transformerless PV inverters can cause capacitive leakage currents, missing equipotential bonding of framework and PV array support structures can pose an electrical shock risk.
