Validation of assembly and deployment quality for a pre-fabricated PV array.

Rhett Evans^{1,2,3,4}, Oliver Kunz¹, Jose I. Bilbao¹

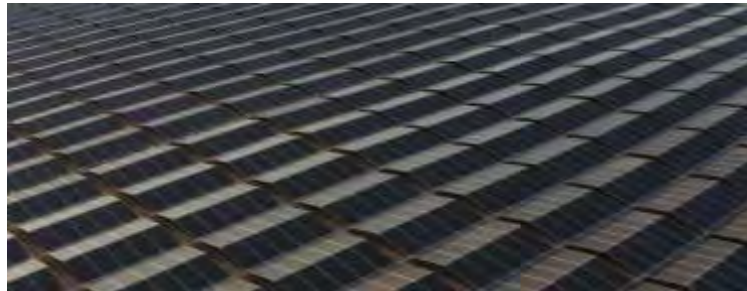
Figure 1. Image of a deployed 5B array in South Australia

5B, a company founded in Sydney in 2014, have developed a solar array structure known by its product name “Maverick”. Maverick is an engineered, pre-fabricated solar array, meaning that assembly of the array takes place in the relatively controlled conditions of a factory. Time spent on the actual installation site is reduced, as is uncontrolled handling of the modules on site. One expectation in designing this approach is that installation quality will be improved, but this expectation must be validated. This study describes an extended trial designed to quantify the risk of microcracking and performance loss during assembly and deployment of this new array structure. This quantification of risk is necessary for continual product improvement and to satisfy module manufacturers that they are not incurring an additional risk when they warranty their modules for use in 5B pre-assembled arrays. As the 5B approach is not a part of standard installation manuals, this special consideration is required of the manufacturers. The extended testing showed a very low risk of module damage during 5B deployment, with five major manufacturers now deploying modules in 5B products under their standard warranty conditions.
